# Historic Texas Landmark Restored for Adaptive Reuse: Everything Old Is New Again

by Stephen Lucy, Dale Sellers, and Mark LeMay

## Dallas Municipal Building: Historic Texas Landmark Restored for Adaptive Reuse

Dallas, TX

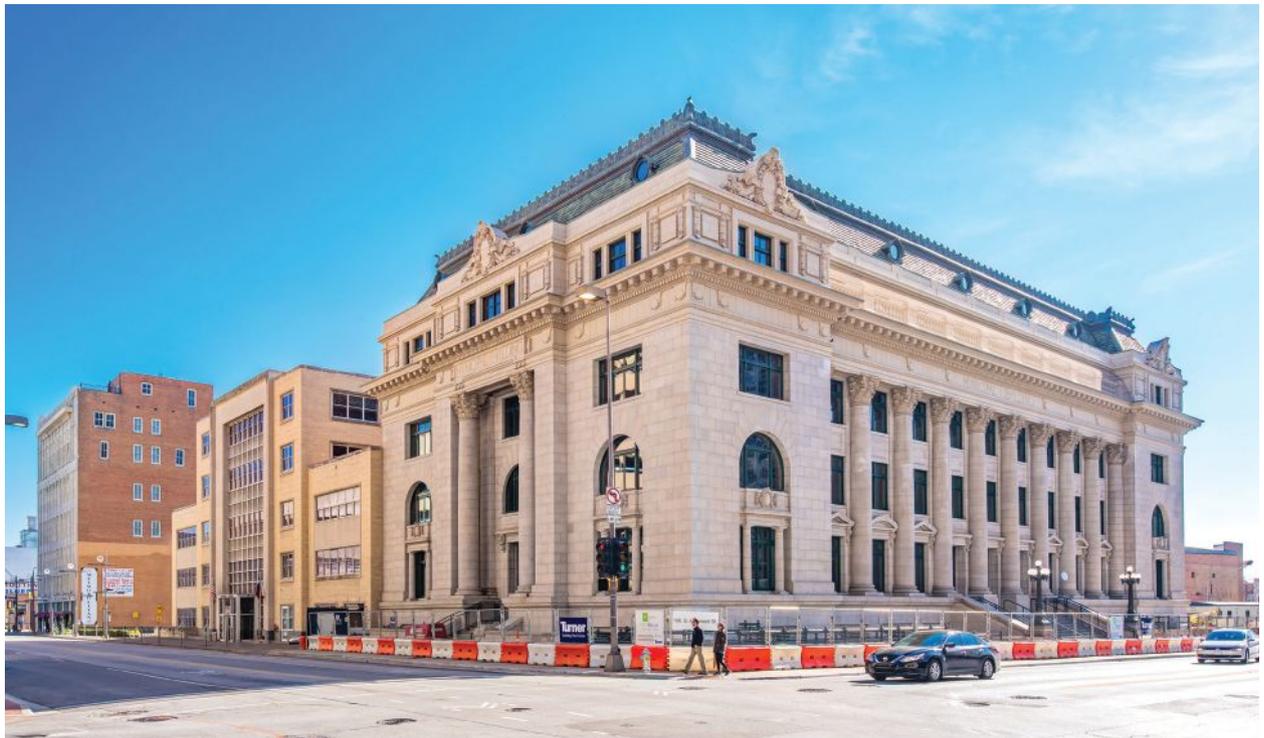
Fig. 1: Nearly finished façade, northeast corner (photo courtesy of Tracy Allyn Photography)

The first phase, completed in 2010, relocated the remaining functions to the annex and other city-owned buildings. Phase two focused on the Municipal Building's exterior restoration, the most extensive historic restoration project the city had undertaken at the time (Fig. 1).

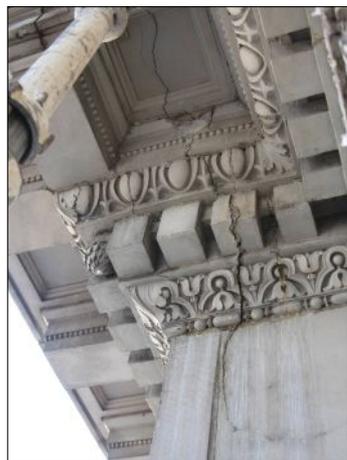
The terra-cotta cornices required thorough investigation, because cracks in the ornamental terra-cotta (Fig. 3), which projected out from the building, created a falling debris hazard. To understand the condition of the framing, the team used a metal scanner to locate anchorage points and opened the top portions of the cornices to investigate the anchorage system. Several anchor elements were rusted completely through (Fig. 4), which posed a danger, so a pinning system was devised for the terra-cotta units. Using long, threaded stainless steel rods, the plan called for holes to be drilled into the terra-cotta and the rods screwed into the background material to secure the terra-cotta. This proved to be an economical, long-term, and permanent re-securement solution for other stone pieces around the building. Access created planning challenges as lifts had to be used instead of scaffolding to determine what materials were needed. Broken sections of the terra-cotta had to be disassembled and removed so the units could be refurbished or measured for fabrication of replacement materials, which took up to eight months. In addition, deterioration of the structural steel associated with the cornices on the outside corners of the building required welding new structural steel members to secure the cornices.

Fig. 3: Cracking in overhead terra-cotta units

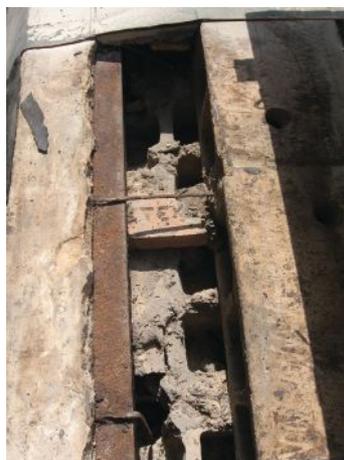
Fig. 4: Two original anchor rods in cornice anchorage system completely rusted through

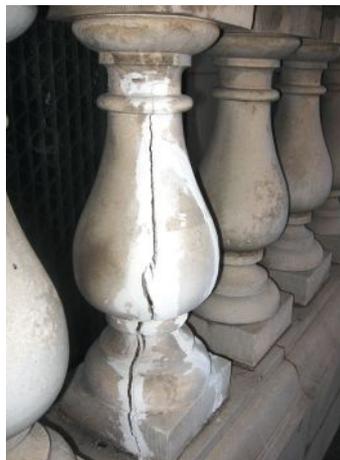
Originally, it appeared that most of the balustrades (Fig. 5) would need to be removed and the corroded steel replaced. However, further investigation revealed the steel deterioration was not as bad as expected and only 10-15 percent required replacement. By reconditioning the steel,

Fig. 5: Cracked baluster

reattaching it and eliminating water infiltration, it was possible to reuse the existing steel.

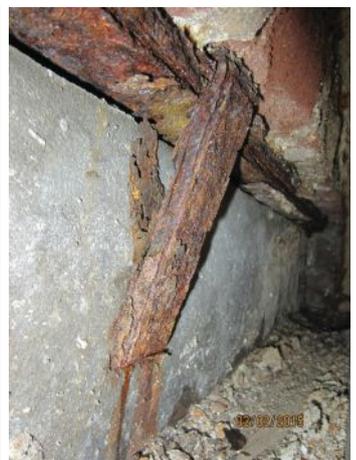
Fig. 6: Corroded steel beam flange and anchor strap slotted into back side of stone lintel

Stone lintels above window openings were suspended from structural steel members, several of which had deteriorated (Fig. 6). The contractor had to carefully remove the stone lintels, install new steel members, and resuspend the stone.

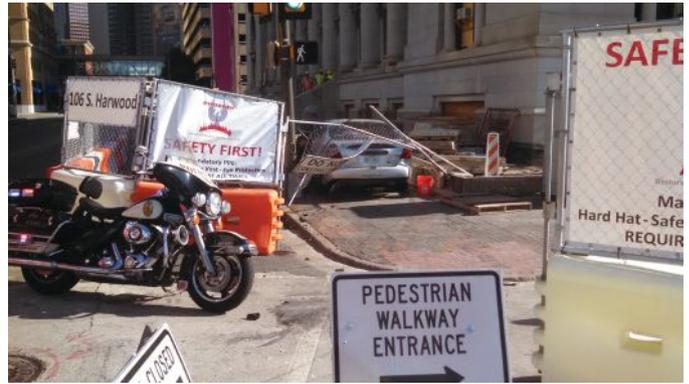
Downtown construction sites are inherently challenging but maintaining ADA access and walking routes along the sidewalks around the Municipal Building's busy location proved even more so. Despite numerous barricades and signs, at least half a dozen vehicles drove through the barricades and onto the construction site (Fig. 2). Fortunately, there were no injuries.

Fig. 2: Despite barricades and signage, a vehicle wrongfully enters the construction site

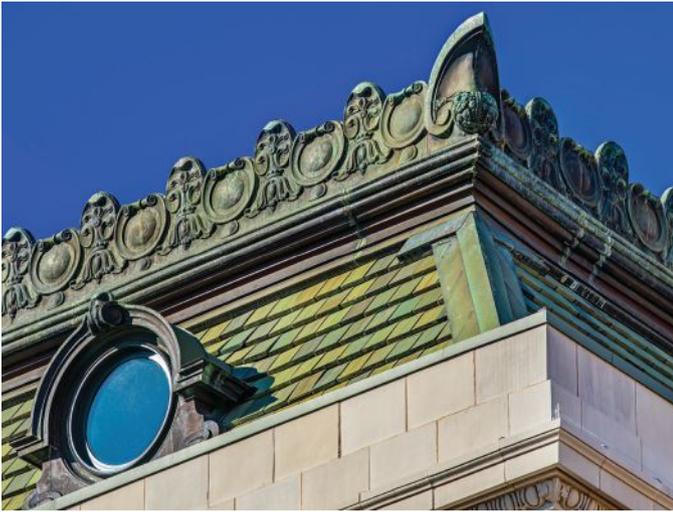
Fig. 7: Restored green clay tile mansard roof (photo courtesy of Tracy Allyn Photography)

The building's multi-system roof is comprised of historical copper guttering and copper dormers, a mansard roof made from green clay tile (Fig. 7), and a conventional flat roof that was originally made from coal tar. All roofing materials were completely removed and replaced or restored, concrete and masonry substates were repaired, and structural repairs were made to the mansard area.

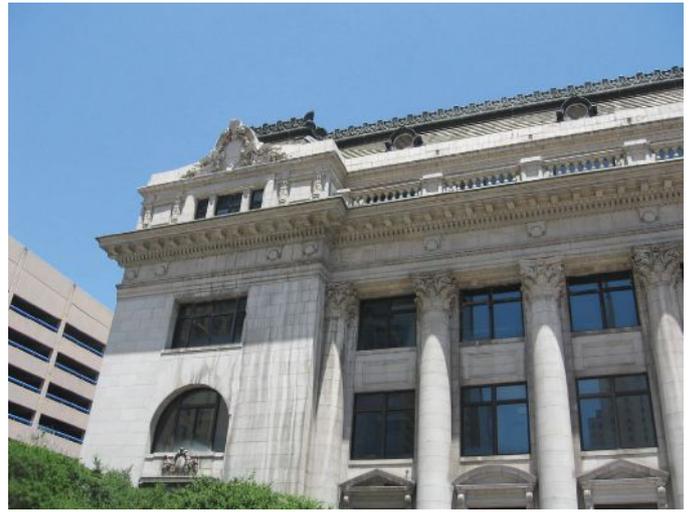
Cleaning the exterior stone presented a significant challenge. Numerous cleaning samples were performed, but because the building had not been maintained (Fig. 8 and 9), dirt was ingrained in the stone to a point that no cleaning agent sufficed. However, honing the stone could return it to its original luster. While typically frowned upon in

Fig. 8: Pre-restoration appearance of the stained building exterior

an historical renovation, the technique was presented to and accepted by the Texas Historical Commission. While unusual, the commission also accepted the project teams' recommendation to replace the windows with custom-made metal-clad, insulated windows that matched the original windows and significantly reduced energy consumption.

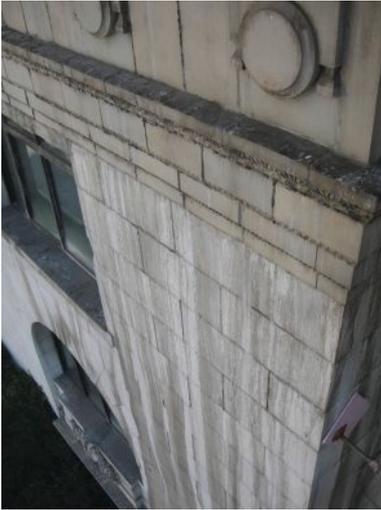
Fig. 9: Extensive staining on exterior stone prior to cleaning

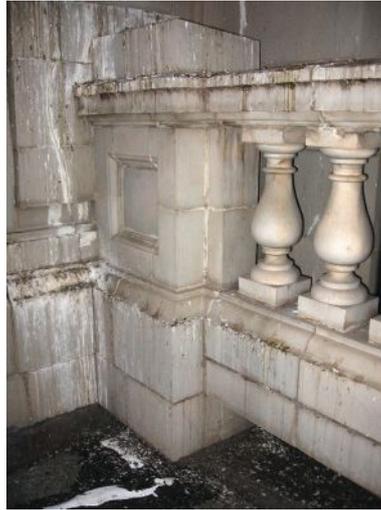
Dirt was not the only challenge faced in cleaning the building. Decades of pigeon excrement (Fig. 10) build-up created a biologically hazardous situation that required a crew outfitted in HAZMAT suits and respirators to clean, scrape, vacuum, and wash the building. The hazardous droppings had to be contained, double-bagged, and properly disposed of. To help alleviate future bird issues, bird netting was installed around the capitals where birds tend to nest and several operable windows were installed allowing maintenance crews access to regularly clean the exterior walls and gutters.

Fig. 10: Pigeon excrement on balustrade
