The Restoration of Texas Courthouses

By Stephen H. Lucy, PE

Case Study: The Ellis County Courthouse, Waxahachie, Texas

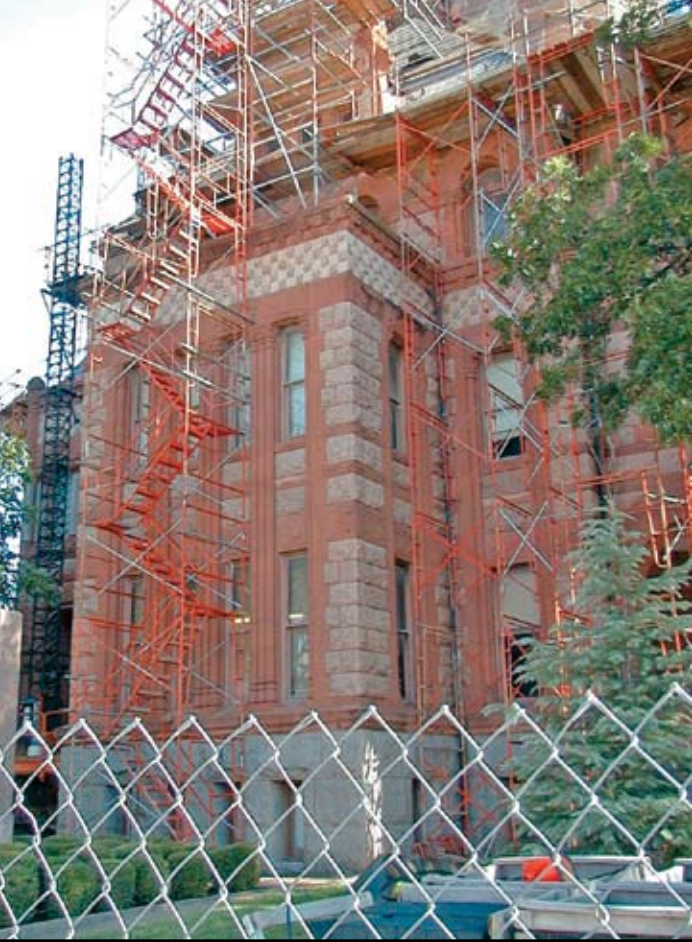
Exterior south stairs scaffolding, Ellis County Courthouse
