May/June 2021  
Vol. 34, No. 3

CONCRETE REPAIR BULLETIN

## POST-TENSION SYSTEM EVALUATION AND REPAIR

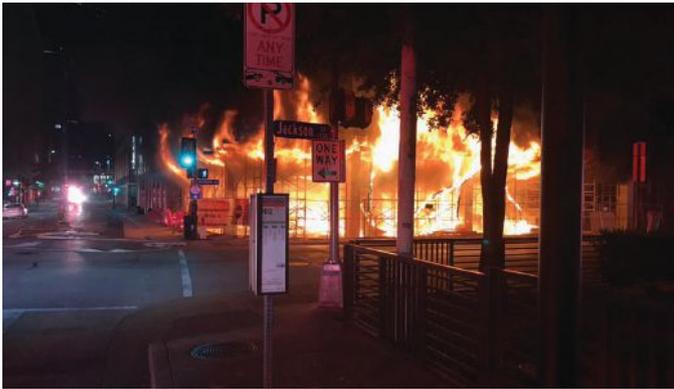
Fig. 2: Flame intensity as the parking garage burned

The three-alarm fire occurred in the early morning hours of September 27, 2017 (Fig. 2). At the time, drilled pier foundations had been installed, one above-ground level had been substantially completed, and formwork and reinforcing steel was in place to construct the east half of Level 3. The engineer

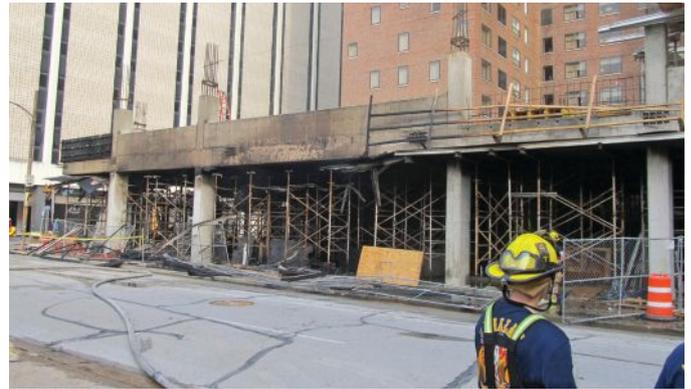
Fig. 3: Fire is extinguished

visited the site a few hours after the fire was extinguished to review the interior of the structure in the immediate area of the fire (Fig. 3). Although there was serious damage to formwork, there were no initial signs of displacement or significant distress in the structure itself. The engineer briefly entered the structure to determine if there was damage to the tower crane, as that would pose an immediate risk. The base of the tower crane, located three bays east of the fire, had smoke damage but no observable damage to the steel structure or to the rubber insulation of the main power cable.

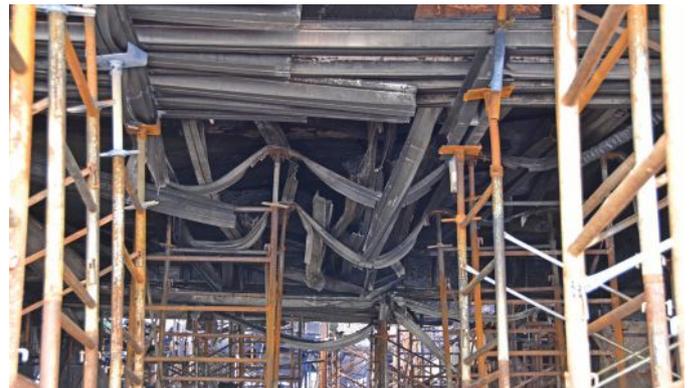
Fig. 4: Melted framework resulting from the intense heat of the flames

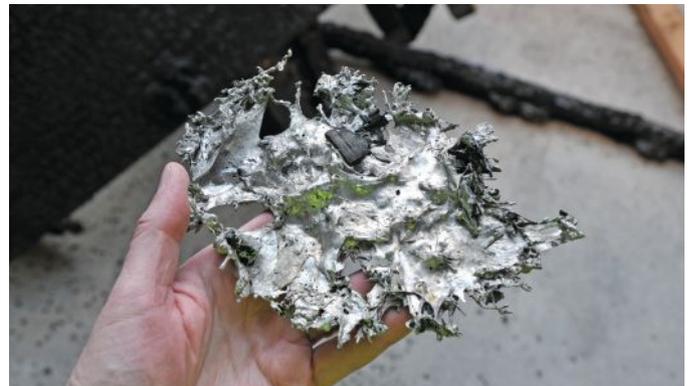
Fig. 5: The fire burned hot enough to melt the aluminum shoring system

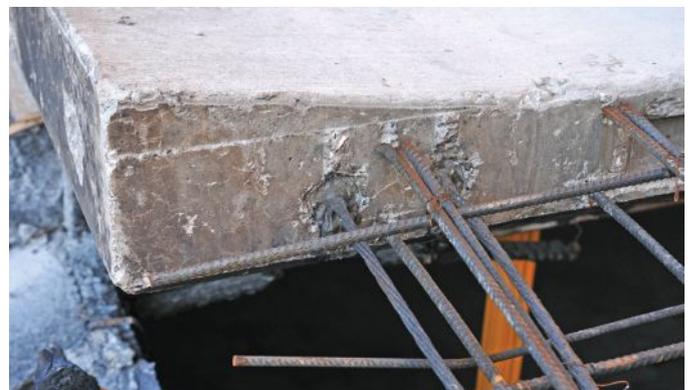
Fig. 6: Ramp slab with melted post-tension encapsulation

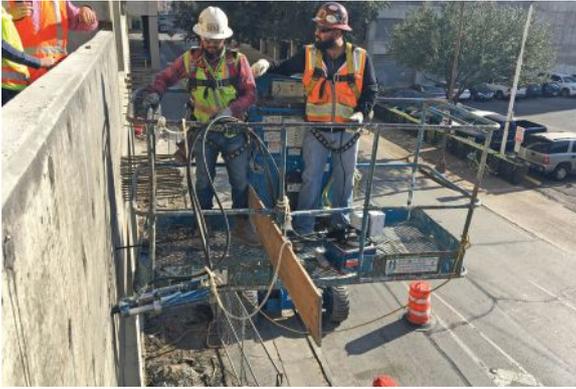
Fig. 7: Initial post-tensioned strand testing

The post-tension supplier was asked to test additional strands that were potentially affected by the fire event (Fig. 7). Forty-four (44) strands were identified, approximately 25 percent of the strands in the area damaged by the fire. Of the first fifteen (15) strands tested, one broke during stressing. The engineers theorized that the strand tails that projected out from the building were subjected to more heat, and thus, potentially more damage the farther they projected from the face of the building. The stressing jack being used for the testing was gripping the strands 12 in (300 mm) or more from the face of the building in this potentially damaged zone. To obtain more accurate test results, a different subcontractor was utilized to test the strands with different stressing equipment, capable of gripping the strands closer to the surface of the concrete. After all the strands were tested using this new equipment, only one broke out of the forty-four (44) strands tested.

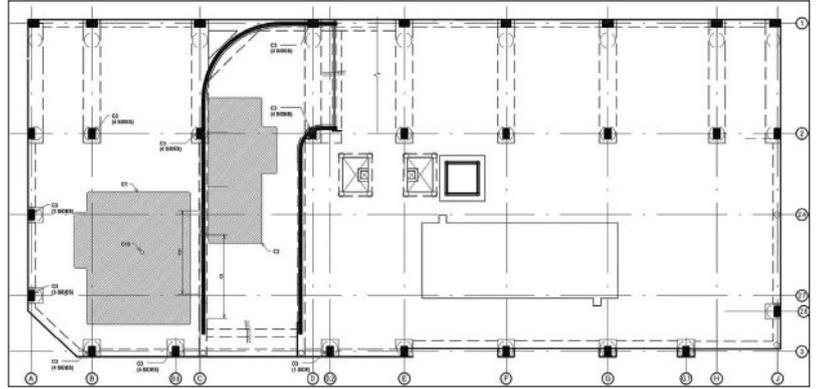
Fig. 8: Slab repairs at Level 1

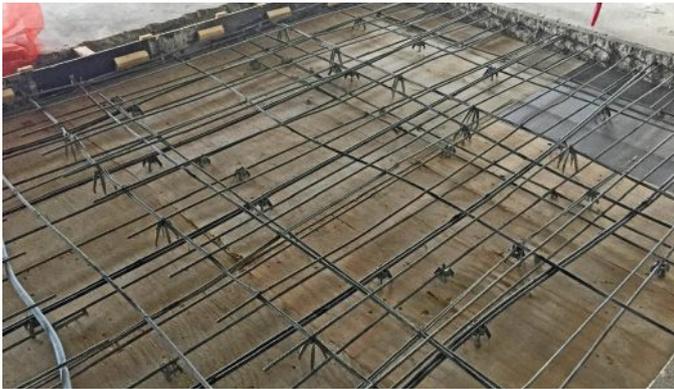
Fig. 9: Reinforcing for Level 2 slab replacement

At the Level 2 slab that was directly over the fire, where two pairs of post-tension strands were exposed by spalling, it was determined that the slab be removed and replaced (Fig. 9). Prior to demolition, all post-tensioned strands in the slabs were de-tensioned. Any heat-damaged strand sheathings and encapsulation systems were repaired during this reconstruction. In addition, during slab removal, additional sheathing was damaged and required repair (Fig. 10), and two strands were damaged and required replacement. Because the main supporting post-tensioned beams remained stressed during repairs, designated areas of the slabs supported by the beams were removed and replaced in se-

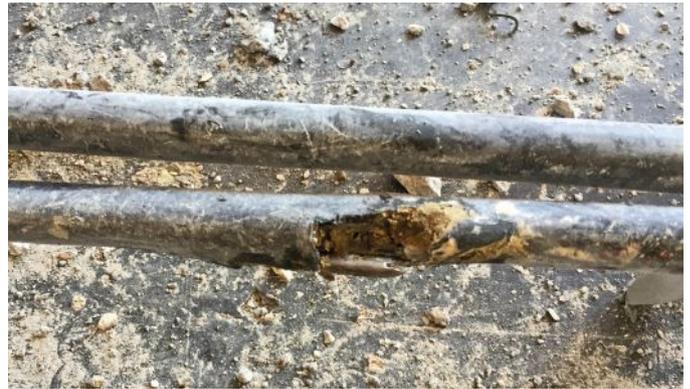
Fig. 10: Post-tension strand damage after slab removal

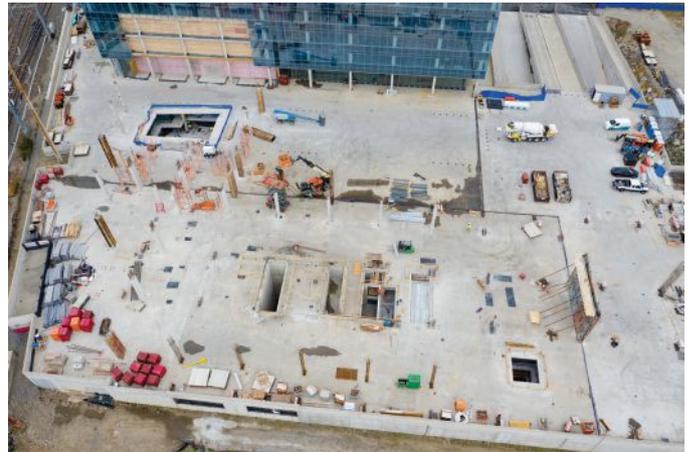
Fig. 2: Gateway Towers 1 and 2 during early construction—PT modification opening shown through the first two levels connecting Tower 1 (already constructed) and Tower 2 (starting concrete frame) (photo courtesy of Baker Concrete Construction)

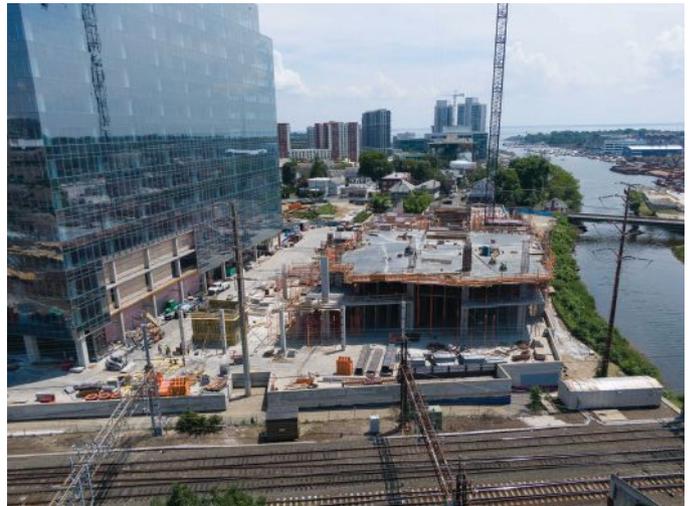
Fig. 3: Gateway Towers 1 and 2 at mid-construction—new core wall construction on the plaza deck between the two new towers (photo courtesy of Baker Concrete Construction)

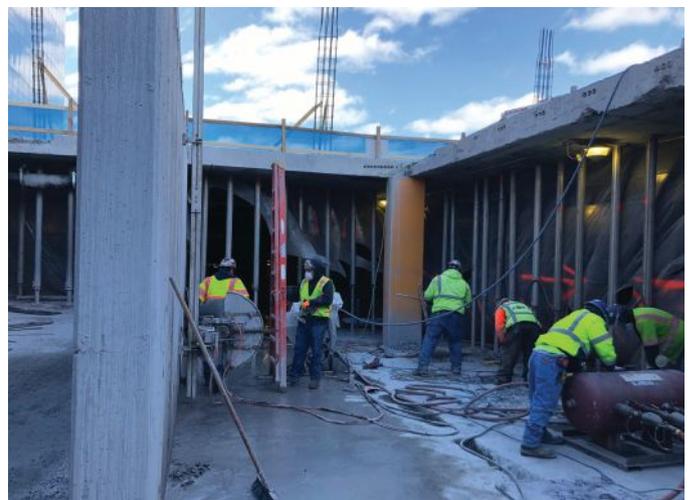
Fig. 4: Shoring, pocket demolition and other PT modifications on Level P1 with the Plaza Level already open above—note number of stressing pockets in the slab

Before starting the work, specific procedures and materials needed for the PT modification were established and discussed. Shoring and working platforms (Fig. 4) were installed on each level to support the elevator/staircase openings and the construction of a new core through the podium.

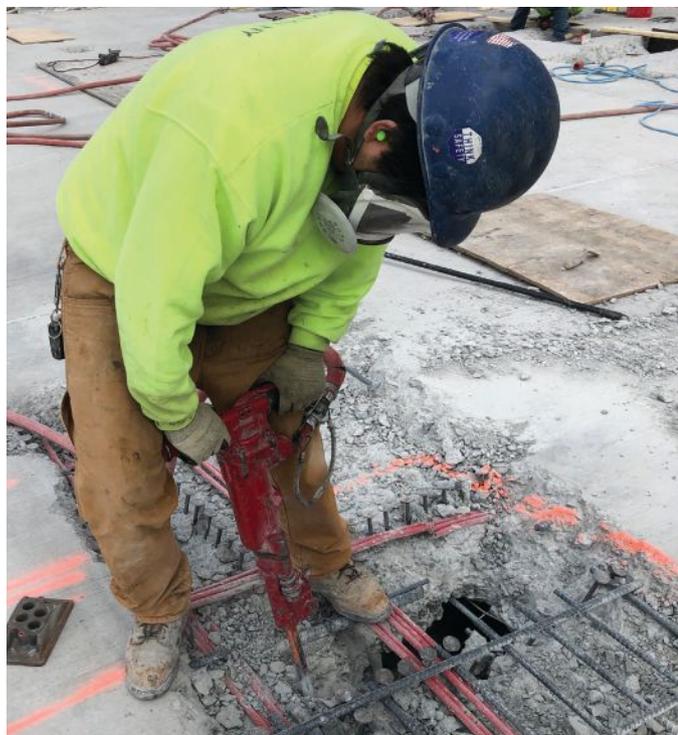
Fig. 5: Removing concrete around existing PT tendons on the Plaza Level

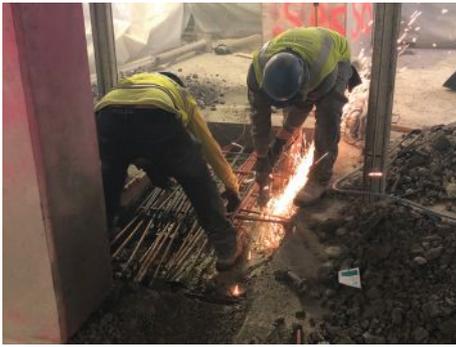
Fig. 6: Controlled de-tensioning of existing PT tendons on Level P2

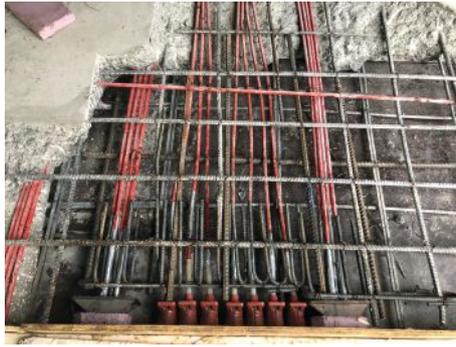
Fig. 7: Modified anchorage detail of banded fifteen (15) tendon bundle at new end anchor location

The encapsulated anchors were then secured with hairpin-like steel bars (Fig. 7), preventing bursting of the slab edge when the re-tensioning was performed with a hydraulic jack. The slab edge and new pockets were formed and poured with rapid-set mortar that quickly gained high-early strength. Then, each tendon was stressed to 33 kips with measured elongation ranging from 2.5 to 6 in (65 to 150

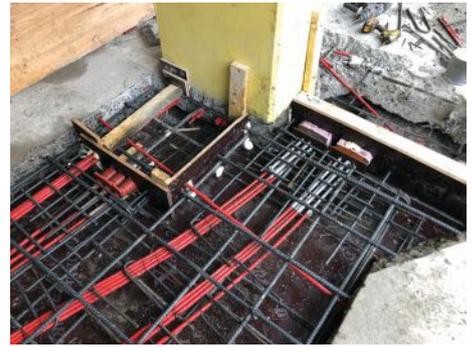
Fig. 8: Modified anchorage detail at column interface

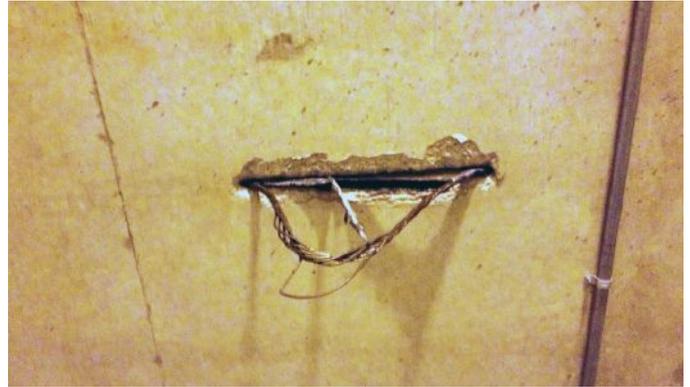
Fig. 2: Erupted post-tensioned tendon discovered March 2013

With the investigation complete, it was determined that voids between the sheath and strand and a lack of protective tendon grease allowed water and chloride ingress

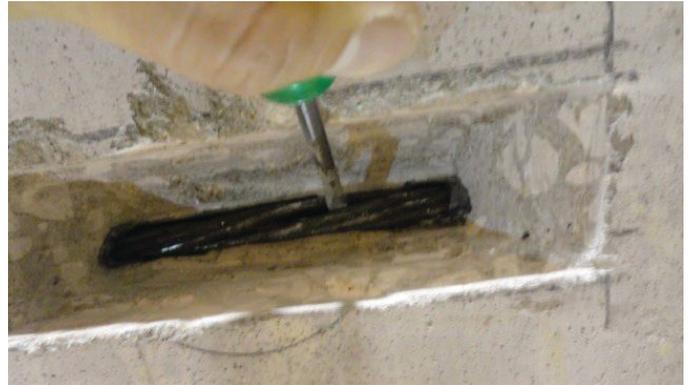
Fig. 3: Screwdriver penetration test detecting broken wires

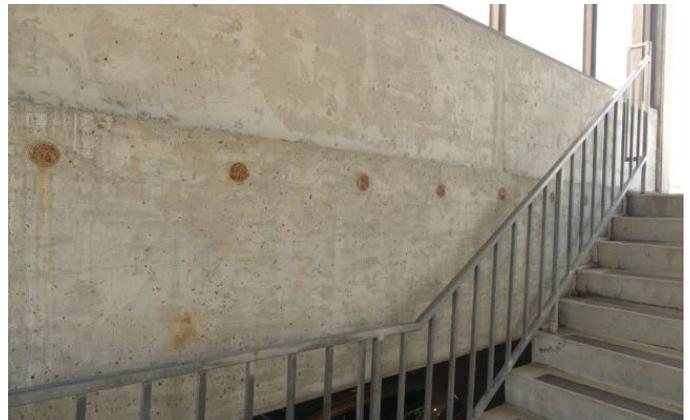
Fig. 4: Corrosion at slab grout pockets

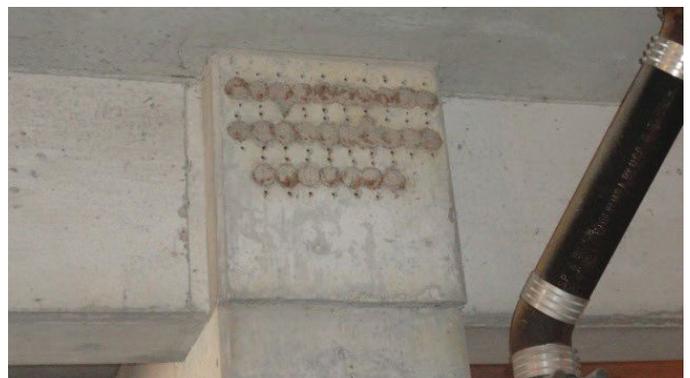
Fig. 5: Corrosion at beam end grout pockets

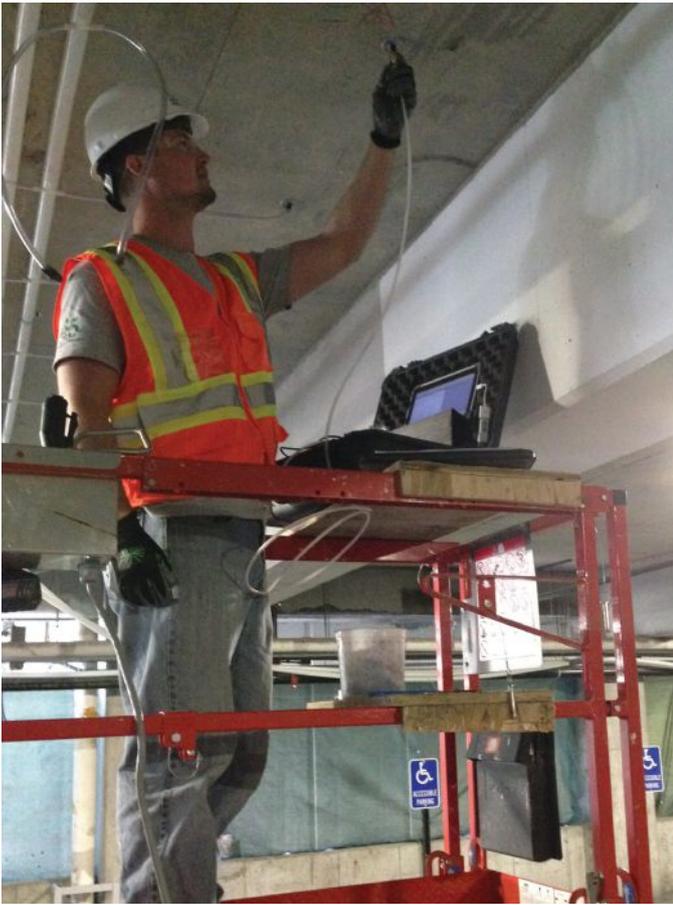
Fig. 6: Post-tension corrosion evaluation procedure (moisture test)

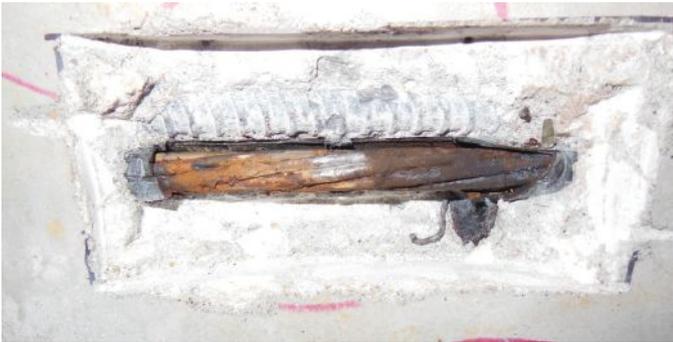
Fig. 7: Severe corrosion and degraded grease

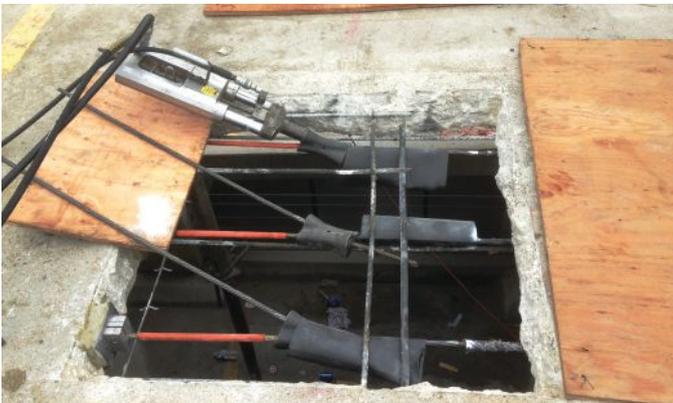
Fig. 8: Post-tension splicing with center stressing chuck

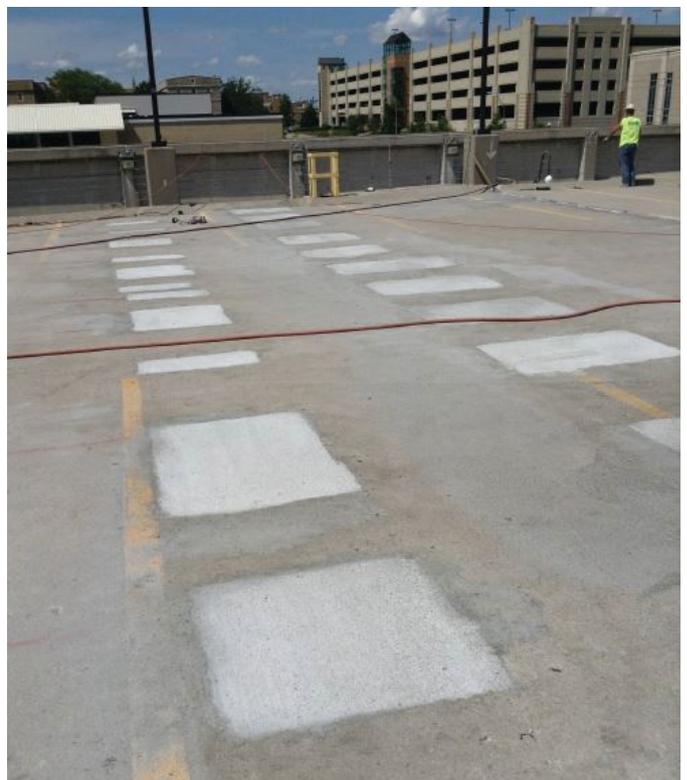
Fig. 9: Completed post-tension repairs

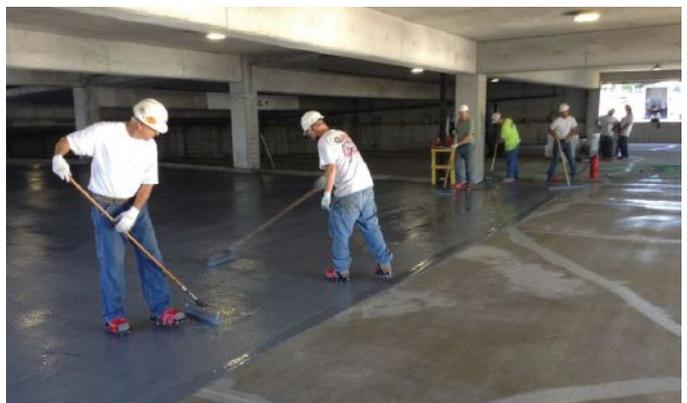
Fig. 10: Application of waterproofing membrane

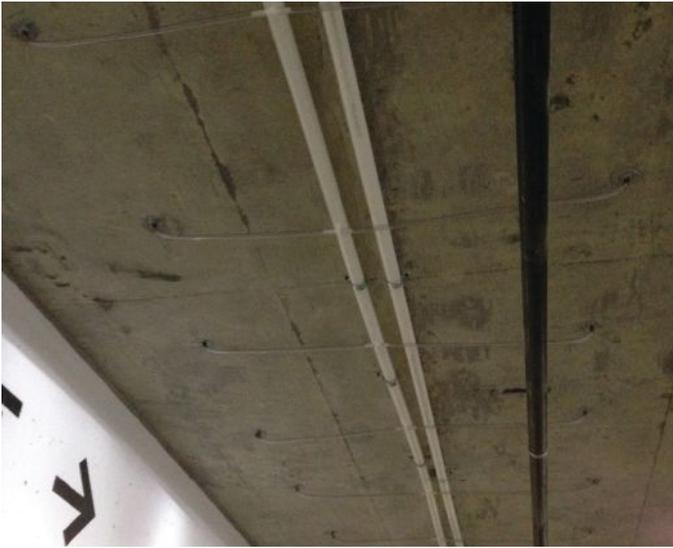
Fig. 11: Manifold system and input air ports for post-tension cable drying

The post-tension cable drying criteria for moisture content was based upon previous studies performed for the National Research Council Canada (Fig. 12).<sup>2</sup> Prior to the post-tension cable drying, the tendons were in a Wet 3 condition with moisture content greater than 0.7 percent with several of the tendons holding bulk water. After the post-tension cable drying process was completed, 98 percent of the cable groups were classified as Dry 1 with moisture content less than 0.3 percent. The remaining cables, classified as Dry 2 with less than 0.7 percent moisture, typically have airflow restrictions, possibly caused by built-up corrosion.

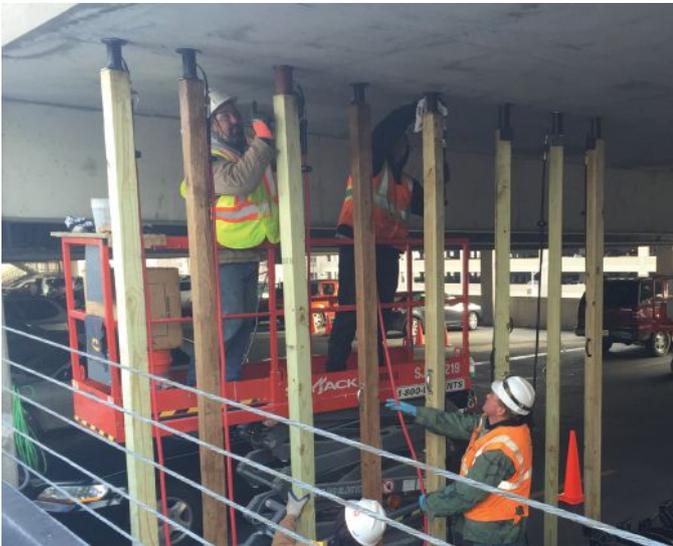
Fig. 13: Post-tension grease injection

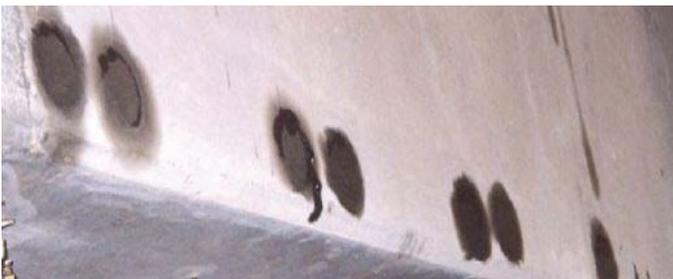
Fig. 14: Post-tension grease at grout pockets
