Hanging Out: Risk Management for Exterior Facades

By David McKenna and Mark LeMay

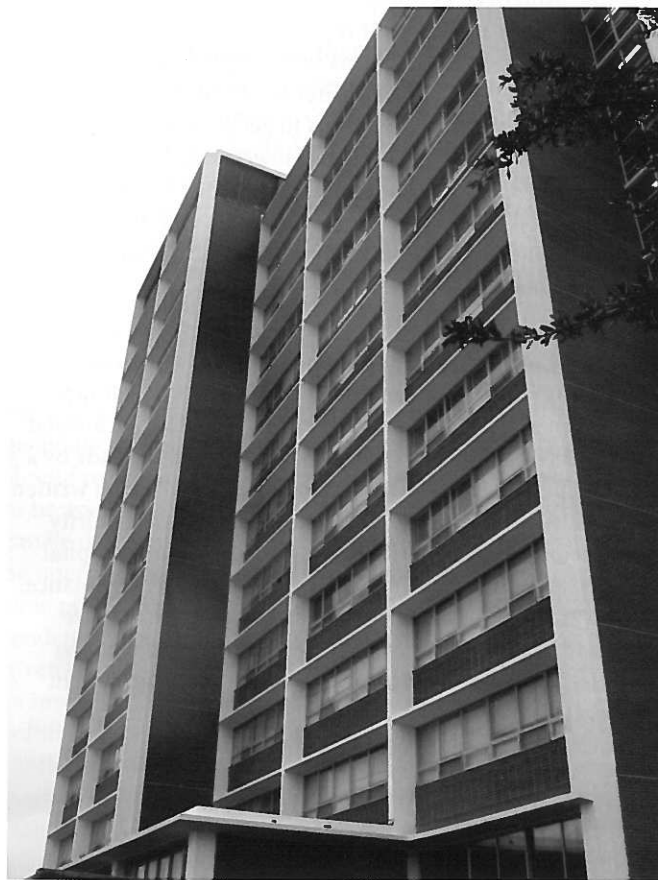
In some rare instances, however, due-diligent monitoring efforts may not be able to detect some potentially dangerous conditions. Such was the case on the night of January 15, 2012, on the campus of Texas A&M University-Commerce when a 12-foot x 12-foot section of brick veneer detached from the 13th floor penthouse level of a building constructed

Figure 1: Detached section of brick at the 13th-floor penthouse

in 1968 and fell onto the parking lot below (Figure 1). High winds, which were estimated at upwards of 65-70 mph, triggered the collapse. Observations of the failed section of brick revealed the *complete absence* of brick ties in the upper portion of the wall (Figure 2). Identifying construction defects such as this would be akin to finding the proverbial “needle in the haystack.”

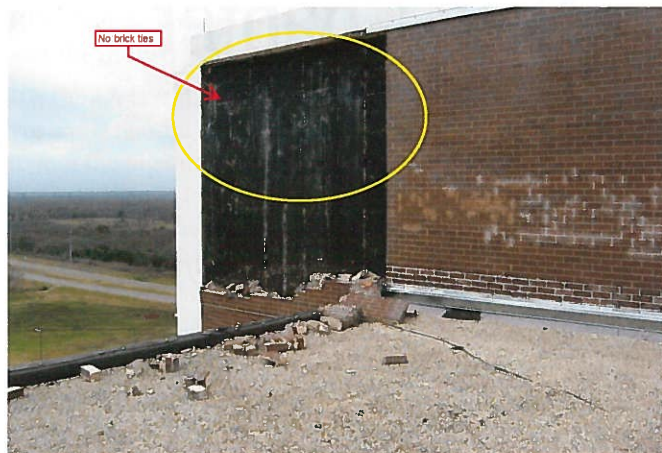
Figure 2: Detached section of brick at the 13th-floor penthouse

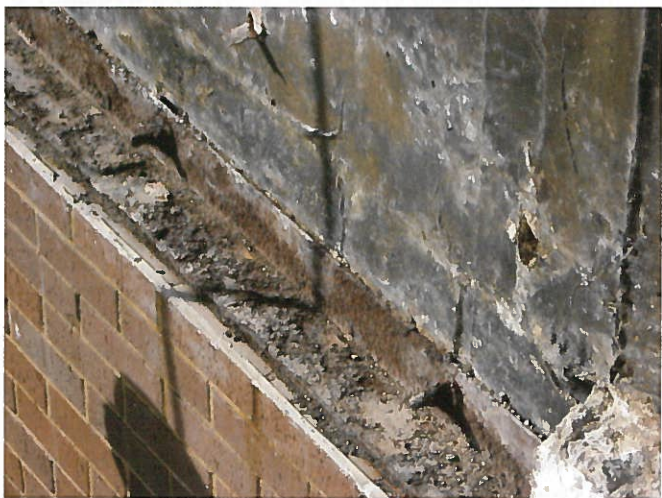
Fortunately, there were no injuries from this event, although there was a small amount of damage to vehicles. Investigations conducted on various sections of the façade also uncovered severe corrosion of brick ties, along with significant corrosion of the steel shelf angles at each floor level (Figure 3).

Figure 3: Corroded shelf angle

Engineering recommendations were quickly reviewed and implemented by University Administration. Over the next six months, work crews removed and salvaged thousands

of brick units, replaced corroded shelf angles, installed new stainless steel brick ties, flashing systems, mortar joints, and weep holes, to restore the structural and waterproof integrity of the exterior skin of the building.

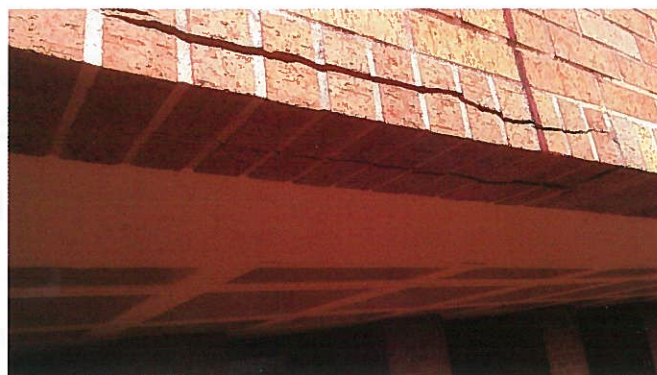
and at a county college both in North Texas have required repairs due to cracked and spalling brick units (Figure 4). Cast in four-foot long units with reinforcing rods grouted in the holes of the brick, the units are hung from steel relief angles. However, moisture intrusion through the brick veneer

Figure 4: Cracked brick soffit units

coupled with improper flashing of the relief angle resulted in corrosion of the grouted reinforcing steel. The expanding volume of the corroding steel cracked the brick units, and eventually caused portions of the brick to become detached. The fact that this section of the façade was located over pedestrian walkways made the situation quite critical.
