Dallas City Hall Plaza Parking Garage Repairs

DALLAS, TEXAS

Wichita Falls ISD Memorial Stadium Assessment and Repairs

WICHITA FALLS, TEXAS

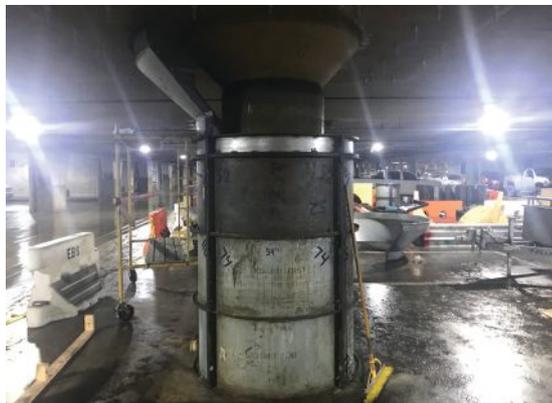
The Dallas City Hall Parking Garage sits under a large, landscaped plaza in front of an iconic I. M. Pei-designed building. The garage structure consists of bonded post-tensioned flat slabs with unreinforced drop panels supported by conventionally reinforced circular columns with conically flared capitals. The upper slab of the garage is sloped and stepped to promote drainage and address changes in surface amenities. This also results in significant variations in soil fill depths as the upper topography also varies greatly. The parking structure is overlain by two city streets and various site amenities including multiple mature trees, emergency access fire lanes, assembly areas, sculptures, and a pool with fountains. The varying depths of soil and diverse site features create large variations in the loading imposed on the garage. Based on the failure of a large section of a drop panel which became detached unexpectedly, a structural

Repairs were developed to strengthen the existing slab and supporting columns and to repair cracking and delaminations in the slab and columns caused by the significantly overloaded conditions. Sequencing of the repair work was also incorporated into the design to allow for the continued operation of the parking structure as it is the sole available space for City Hall staff parking. This project and the techniques used for evaluation have provided the basis for several continuing educational courses presented to engineers across the nation.

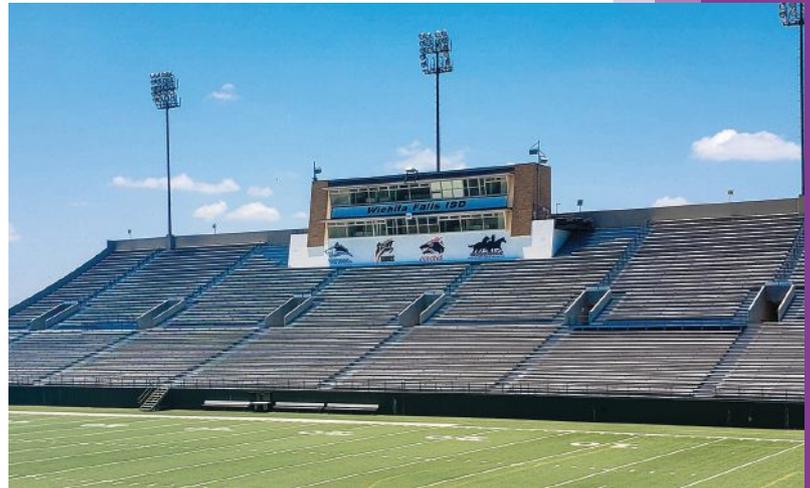
Once the structure of the treads and risers had been repaired, cracks in the top surface of the treads and vertical faces of the risers were routed and sealed with a single-component urethane-based traffic use joint sealant. All cracks with widths greater than .0625 in (1.5875 mm) were addressed to be compatible with the

traffic coating. In addition to addressing cracking in the structure, all expansion joint materials were removed and replaced with new expansion joint seals in properly refinished and prepared joints. Spandrel beams on the ends of the seating structures had failed where the beams connected to concrete walls on the lower end of the slope. The repair required establishing a new expansion joint at the lower end of the spandrel beams to relieve thermal stresses and stresses caused by potential future foundation movements. The spandrel beams were shored, all cracked concrete was removed, reinforcing in the beams was reestablished, a new expansion joint was established between the beam and supporting wall, and the concrete was replaced. A new wall coating was applied over existing wall surfaces.

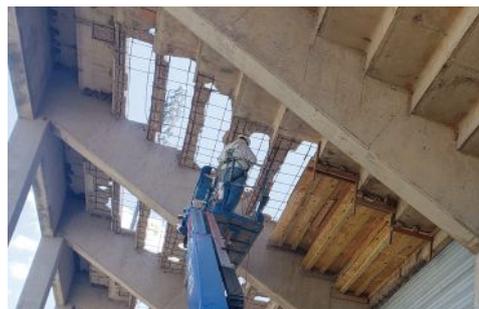
After completion of the structural repairs and application of new joint sealants and deck coating, the aging 50-year-old stadium has new life and can continue for many years to host sporting events for Wichita Falls Independent School District.
