Breathing life into a 101-year-old coffin factory

HISTORIC BUILDING'S TRANSFORMATION INTO HOTEL REQUIRED NEW SERVICE CORES, FOUNDATIONS AND FRAMEWORK FOR ROOF AMENITIES.

By Carlo Taddei, P.E., LEED AP; Douglas Rothermel, P.E., S.E., LEED AP

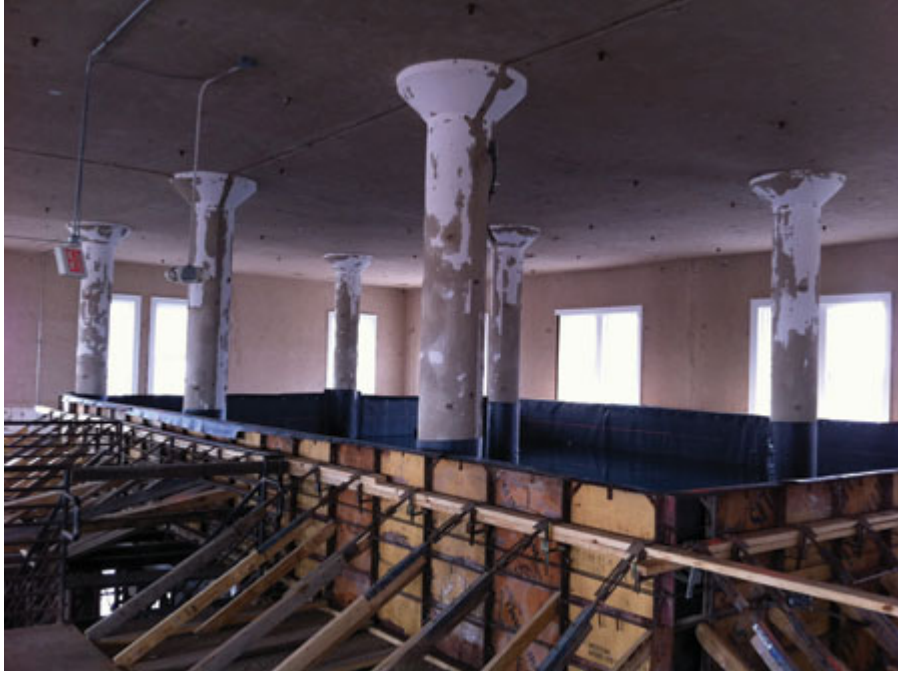
Above: Load test procedure at second level.

As the service core floor openings disrupted the continuity of the slabs, a finite element model (FEM) was created to determine the required supplemental reinforcing. A baseline model was established by modeling the slab without openings using the assumed loading for the original building usage. This model was compared to a second model with the openings included, using current code stipulated design loading. Where the models indicated that significant carbon fiber polymer (CFRP) reinforcing would be required, load tests were performed in accordance with ACI 318-05, Chapter 20, to verify the capacity of the slab in an effort to reduce reinforcement quantities. Tests were performed adjacent to an existing stair opening similar in configuration to the new service core. The load tests were successful, allowing CFRP quantities to be reduced substantially.

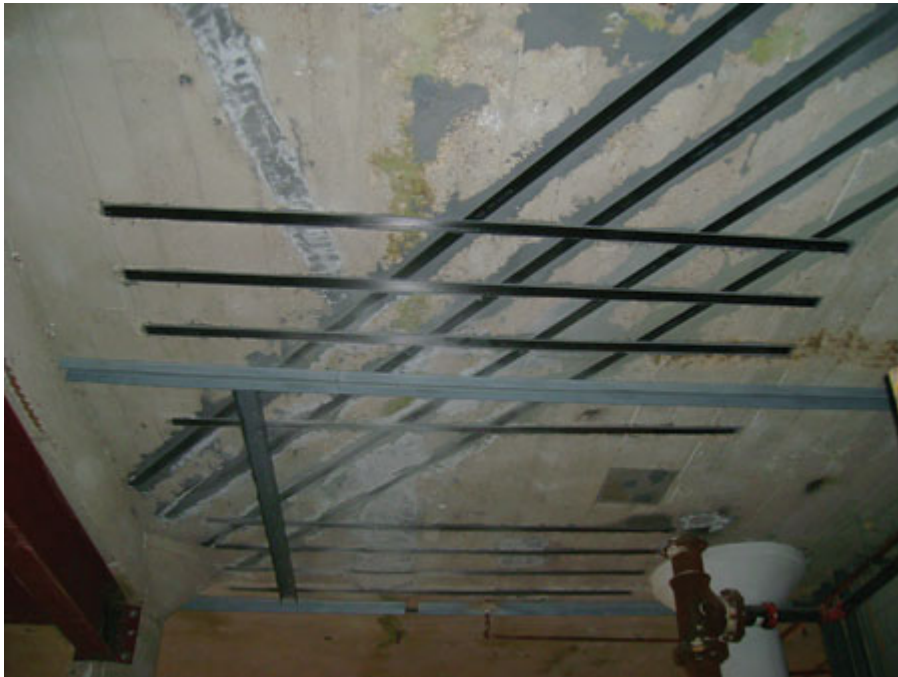
Below: CFRP strips externally bonded to underside of existing slab adjacent to new service core.

Similar to other historic buildings, existing building systems and paths of egress did not meet current building code requirements. Therefore, new service cores were required to extend from the basement to the new rooftop deck. At these new openings, supplemental support for the slab was provided by new 6-in. load-bearing masonry walls around the perimeter of the shaft(s). In addition to supporting the new cores, the shaft walls were designed to take a portion of the lateral loads at each existing level due to the discontinuities in the floor diaphragm created by the new shafts.

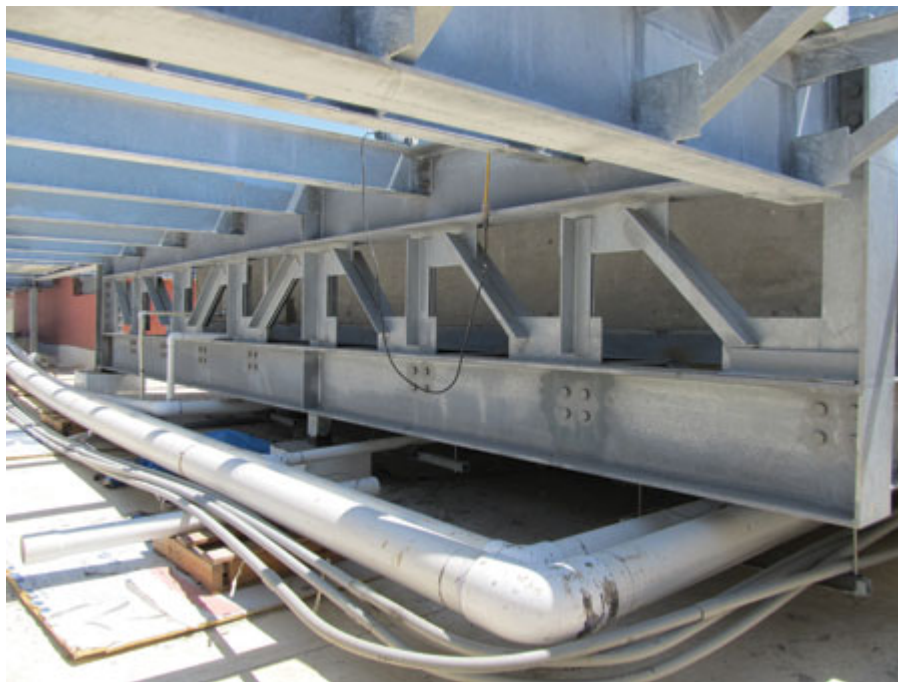
Cantilevered galvanized steel truss on east side of pool, looking southwest.

Because the roof was to be occupied, the existing roof framing was not capable of supporting the new loading demands without significant reinforcement. However, the existing columns were adequate to support the higher loading. Therefore, the amenities deck and pool structure were elevated above the existing roof by a steel framework "stubbed-up" with new steel columns aligned with the existing building columns. To maintain the concept of the deck and pool "floating" above the existing structure while not attaching to the perimeter load-bearing walls, a cantilevered steel truss was utilized along the east side of the pool to transfer the loads back to the interior building columns. The bottom chord of the truss provided support for the pool substructure, and the top chord provided support for the upper pool deck.

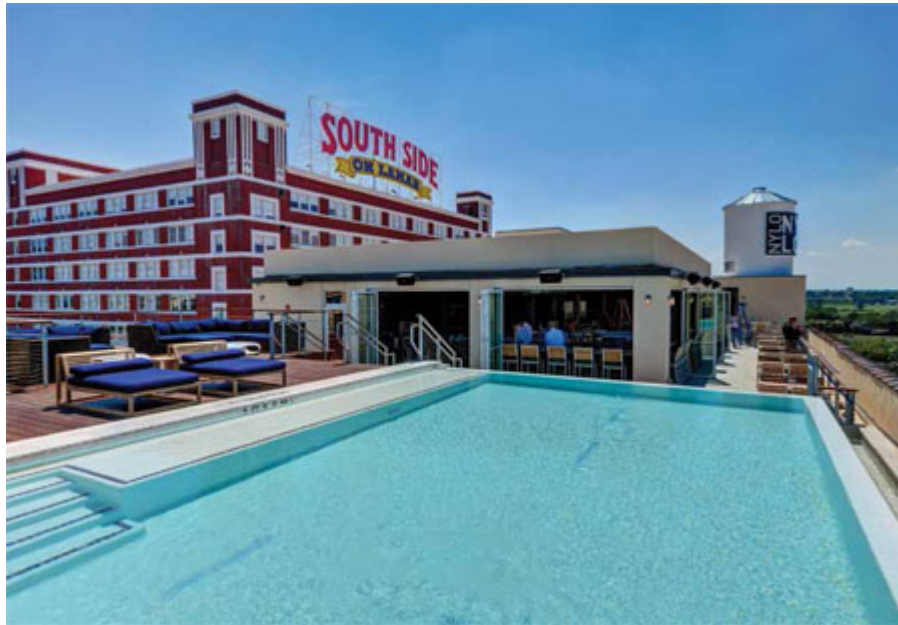
New rooftop amenities deck and "faux" water tank, looking west.
Photo by 5G Studio Collaborative
